Manhole Inspection Summary

Manhole # S31YY1005MH

Insp Date: **1/17/07 10:56 AM**

Location Address: **117 UPNOR RD**

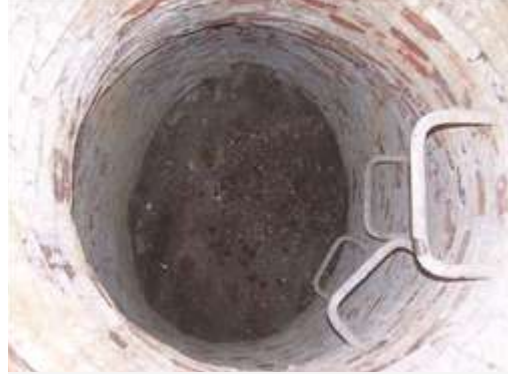
Top View

Channel debris.

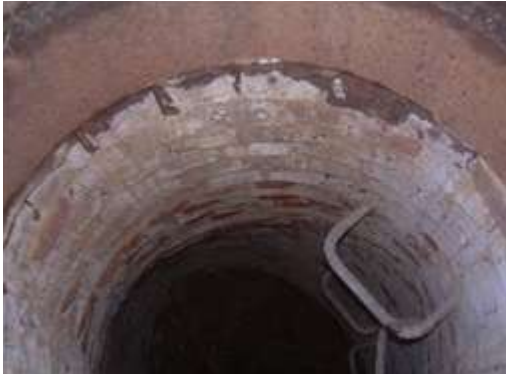
Defect

Frame leaks. Adjustment deterioration and infiltration - other side.

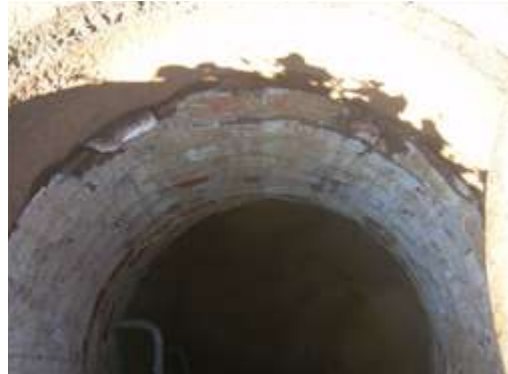
Defect

Frame leaks. Adjustment deterioration and infiltration.

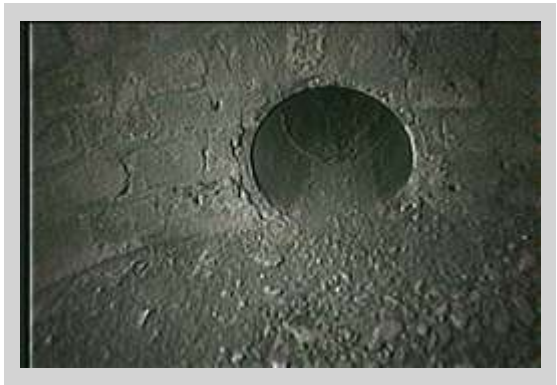
8 in. Circular Gravity Sewer
Pipe Out @ 12 O'Clock

Deposits: ☐ None ☒ **Mud** ☐ Sludge ☒ **Debris** ☐ Grease

Infiltration: **Evidence** Pipe Seal Cond: **Unknown**
